Long-Term Immersion Testing of Alloy 22 and Titanium Grade 7 Double U-bend Specimens

K. J. Evans, M. L. Stuart, P. D. Hailey, R. B. Rebak

February 13, 2007

2007 ASME Pressure Vessels and Piping Division Conference
San Antonio, TX, United States
July 22, 2007 through July 26, 2007

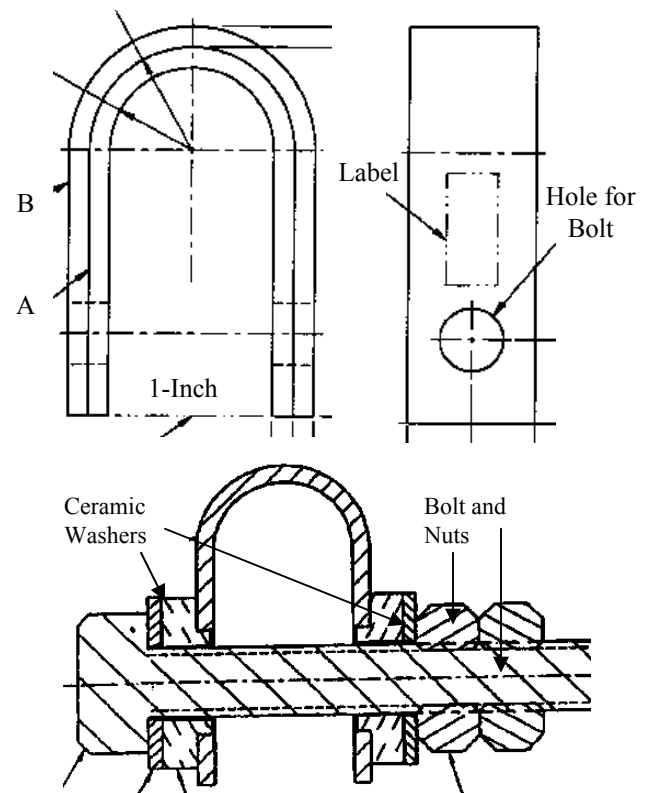
Figure 1. Alloy 22 and Ti Gr 7 Double U-bend Specimens

The Alloy 22 and Ti Gr 7 tested specimens were double U-bends, that is, they were composed of two self nesting strips of material (Figure 1). Each U-bend specimen is designed according to the guidelines in ASTM G 30. The double U-bend specimens are suitable for detecting at the same time environmentally assisted cracking (under constant deformation tensile stresses) and crevice corrosion in the occluded region between both strips and under the ceramic washers. The thickness of the Alloy 22 strips was 0.071 inch (1.8 mm) and the thickness of the Ti Gr 7 strips was 0.059 inch (1.5 mm). The internal strip specimen is the A-type and the external is the

B-type, that is, there is a crevice between the inner surface of the B specimen and the outer surface of the A specimen.

chemical composition is the measured before the tests started, the second is the value provided by the alloy producer). The chemical composition of the material was measured by Laboratory Testing Inc. (LTI) (Pennsylvania). The mechanical properties and other metallurgical properties were also determined by LTI (Table 3). The mechanical properties listed in Table 3 are typical for Ti Gr 7 (ASTM B265) and Alloy 22 (ASTM B575). The double U-bend specimens were manufactured by Metals Samples (Alabama). They were mounted with the bolt and nuts so that the internal radius of curvature was 0.5 inch and the internal separation between the two legs of the A specimen (at the bolt location) was 1 inch (Figure 1). The specimens were electrically isolated from the bolt and nuts by ceramic washers or spacers.

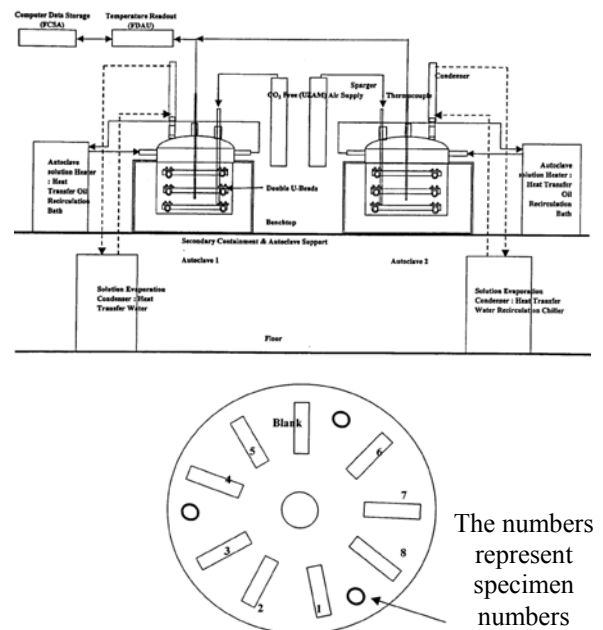
Figure 2. Experimental set-up

Figure 2 shows the experimental setup. The Ti Gr 7 specimens were exposed in Vessel 1 (or Autoclave 1) and the Alloy 22 specimens were exposed in Vessel 2. The vessels were made using double walled glass. The solution in the

vessels was heated by oil circulating in the jacket between the double walled containers. The temperature of the oil was adjusted so that the temperature in the center of each vessel was 105°C. The temperature of the oil pumped in the jacket was generally in the vicinity of 125°C. At the beginning of the tests the aim of the temperature of the BSW solution was 109°C but it was later set to 105°C. The temperature was automatically recorded every hour. Figure 3 shows the temperature as a function of time for an approximately 2-week period in September 2000. In Figure 3 the average temperature in Vessel 1 (Ti Gr 7) was $106.92 \pm 0.37^\circ\text{C}$ and in Vessel 2 (Alloy 22) was $106.25 \pm 0.26^\circ\text{C}$.

Air free of CO₂ was circulated in each vessel at a rate of 30-40 cc/min. The air exited the vessels through a condenser. The initial volume of BSW solution in each vessel was 5.7 liters. The solution level in each vessel was monitored and adjustments were made weekly using de-ionized water. In each vessel the specimens were suspended in three different levels or tiers. Initially, 20 specimens of each alloy were installed in each vessel. Figure 2 shows specimens 1-8 in the bottom tier. Specimens 9-16 were in the middle tier and specimens 17-20 were in the top tier.

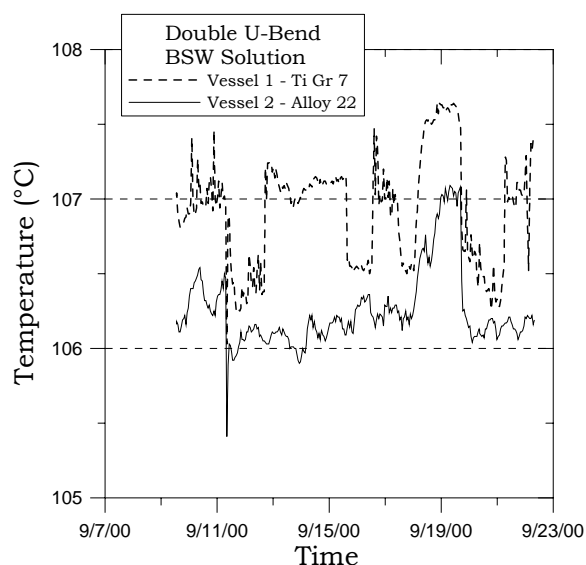
Figure 3. Hourly temperature vs. time in September 2000

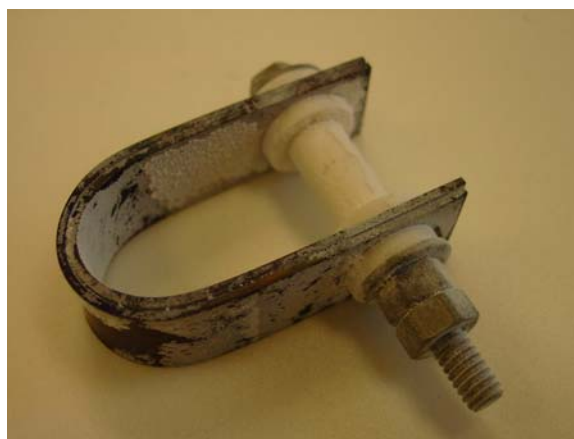
Figure 4. Double U-bend Ti Gr 7 Specimen 9A/9B as removed from Vessel 1

Table 4 shows a list of the specimens removed from Vessels 1 and 2 at the end of the tests. All the specimens were covered with a thick layer of crusted white salt. The Ti specimens were black or exhibited a dark blue tint and the Alloy 22 specimens were shiny metallic, appearing to be plated. Figures 4 and 5 show the appearance of the specimens as removed from the vessels.

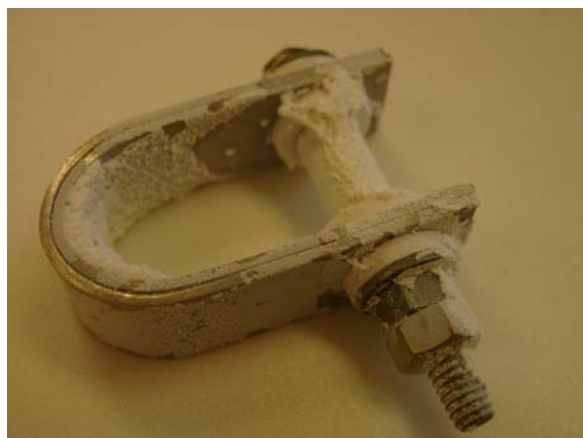
Figure 5. Double U-bend Alloy 22 Specimen 9A/9B as removed from Vessel 2

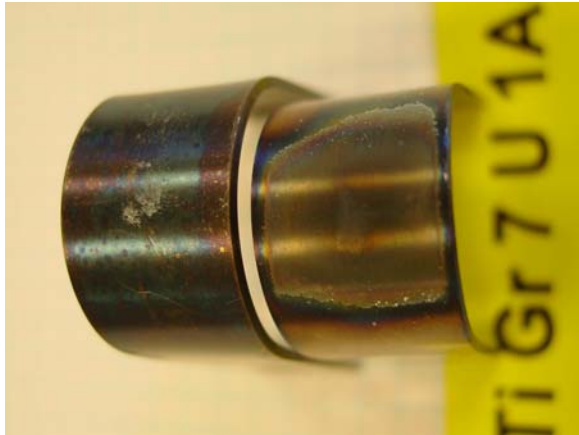
Figure 6. Ti Gr 7 Specimens 1A and 1B (left) after disassembling

None of the disassembled double U-bend specimens showed any evidence for crevice corrosion between the Type A (inner) and Type B (outer) specimens. It is evident that Ti Gr 7 specimens showed a different discoloration at the point where the metal sheets touched (more brown) than at the points where a bigger gap may have existed (more blue) between the metal sheets A and B. Inspection in the SEM showed that the more brown area of contact between the Ti inner and outer specimens was due to the formation of thicker oxide, but localized corrosion was not found in this area. On the other hand, Alloy 22 was free of any discoloration that could be different from the plated-like surface observed before disassembling the specimens. Inspection for crevice corrosion was also conducted under the ceramic spacers or washers used to isolate the specimens from the bolt. No preferential attack was found under the crevice former. Figure 8 shows high magnification appearance of the surface of the Ti Gr 7 10B specimen of the surface outside and under the crevice former. In both cases the grinding marks of the specimen are visible. The grinding marks are clearer on the surface outside the crevice former. It is speculated that a thicker oxide film formed under the crevice former, slightly masking the sharpness of the grinding marks. For Alloy 22 1B there was less difference in the appearance of the surfaces outside the crevice former when compared to the surface under the crevice former (Figure 9). However it appears that the grinding marks are clearer under the crevice former than on the surface exposed to the bold solution. It is speculated

that a thicker film may have formed on the surface outside the crevice former.

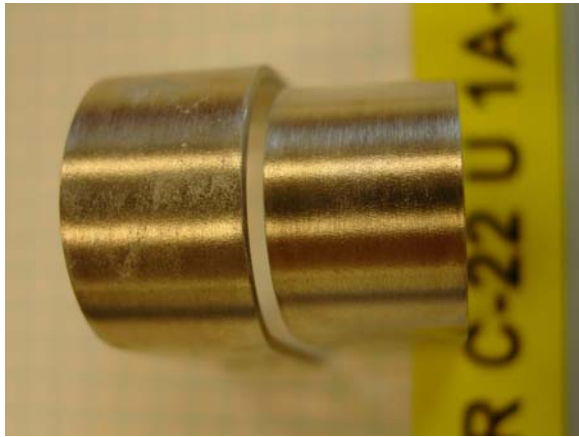
Figure 7. Alloy 22 Specimens 1A and 1B (left) after disassembling

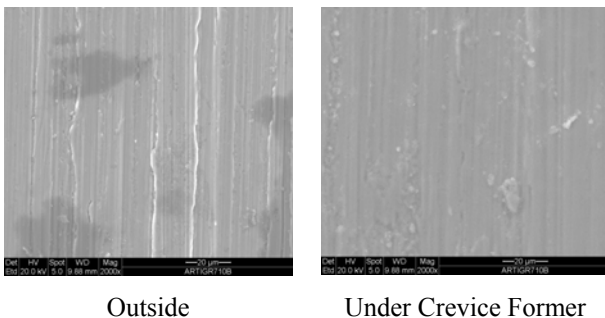
Figure 8. Ti Gr 7 10B, X2000 Magnification

Three Double-U Bend specimens of each material were washed with DI water and the bolt was removed for a complete inspection of the specimen. Even after washing for long time periods in water, some salt still remained on the specimen but this was not an impediment for the inspection. From Vessel 1, specimens AR Ti Gr 7 U 1A-1B, 10A-10B and 20A-20B and from Vessel 2 specimens AR C22 U 1A-1B, 10A-10B and 14A-14B were disassembled. Figures 6 and 7 show a detail of the apex of Ti Gr 7 and Alloy 22 1A and 1B specimens, respectively. None of the specimens showed environmentally assisted cracking. The Ti Gr 7 1A specimen showed a discoloration with a spot in the center. Scanning electron microscopy (SEM) confirmed that this was a thicker browner oxide but localized corrosion was not observed.

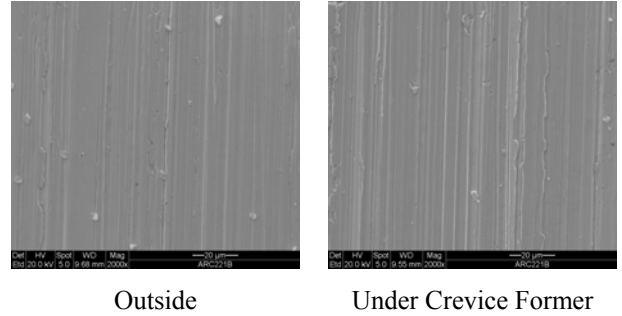
Figure 9. Alloy 22 1B, X2000 Magnification

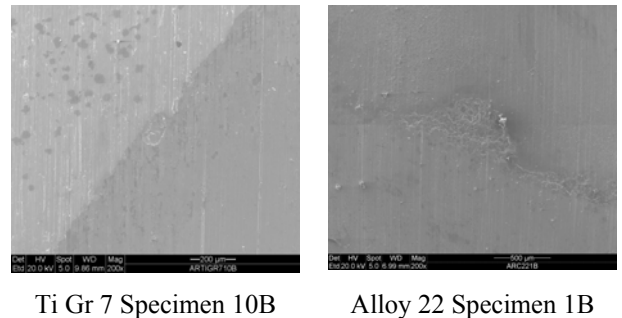
SEM studies of the specimen type B surface at the edge of the ceramic washer also showed minimal corrosion. This was only evidenced in one out of three specimens examined for each alloy. Figure 10 shows the aspect of the attack for both Ti Gr 7 and Alloy 22 at the washer position interface. The attack is small in area and shallow since the grinding marks are still visible over the attacked areas.

Figure 10. Ti Gr 7 10B and Alloy 22 1B, Magn. X200
